# THE DOME OF THE ROCK IN JERUSALEM

A Description of its Structure & Decoration

ERNEST TATHAM RICHMOND

FELLOW OF THE ROYAL INSTITUTE OF BRITISH ARCHITECTS  
CONSULTING ARCHITECT TO THE NOBLE SANCTUARY IN JERUSALEM

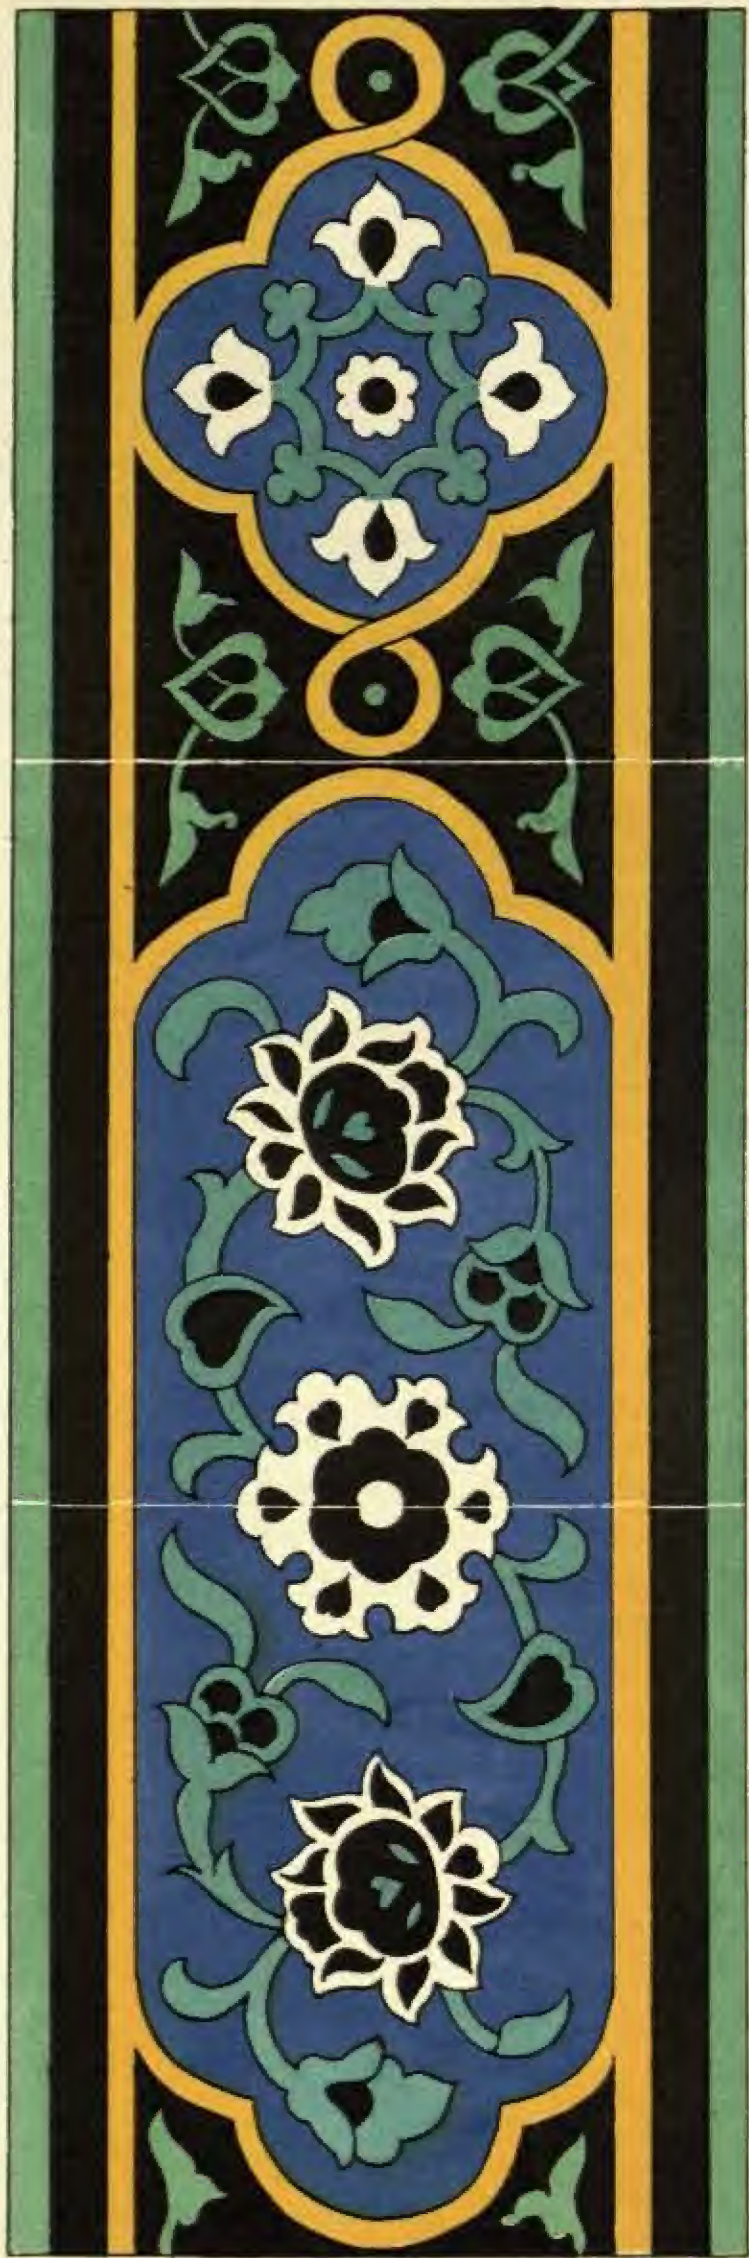
Fig. 22. Later phase of Second Period

Scale 1:2-73

Among the tiles allotted in the chronological diagrams to the second period there remain two more distinct groups to be described. It is in these two groups that the first dates are found. The tiles composing the first of these two groups show a further development and elaboration of the floral motives already illustrated; an increased freedom of line; the use of all the colours (black, white, dark blue, turquoise, green, and yellow) found in the earliest tiles, but with this important difference, that whereas in the earliest tiles all six colours are found on a single tile, producing the richest effect imaginable, in the tiles of the group now being discussed there are never more than four colours on any one tile, and more frequently only three, and sometimes only two. The whole colour-effect is consequently much less rich. White, yellow, turquoise, green, and dark blue are all used as grounds. The colours are still very evenly laid on and carefully stippled. Fig. 22, illustrating the

pattern round the inscription above the south door, gives an example of this category of tile. Other examples are the inscription above the south door; the lintel of the south door, Fig. 24; a proportion of the tiles forming the cornice, Fig. 25; the almond-tree decoration of the abutments to the arch of the south portico, Fig. 28; some of the spandrels, above the arches of the windows in the octagon, Fig. 31 especially on the south, south-east, east and north-east façades, and to some extent on the north façade; some of the rain-water gargoyles, notably on the north-east façade; a considerable proportion of the tiles forming the window borders (these tiles, see Fig. 26, are of the same design as that shown in Fig. 21, but the parts there coloured yellow and those coloured green are left white); small panels found on the east, south-east, and south façades, and containing either of the following inscriptions لا اله الا الله حقًا حقًا; لا اله الا الله ايمانًا و صدقًا; the voussoir-shaped tiles, Fig. 27, round the arch of the north portico; the tiles forming small panels at the feet of some of the piers on the north-east and east fronts (Figs. 32 and 33); the design shown in Fig. 33 is in turquoise on a white ground. Other varieties exist either on the Dome of the Rock or the Dome of the Chain. These varieties are black on a turquoise ground, black on a green ground, and in the Museum now being formed in the Mugharba mosque is a fragment showing the same design in black on a yellow ground. Belonging to the same period are many of the pierced tiles filling the window openings (Figs. 29, 30, and 36); a number of tiles of the design shown in Fig. 20 but coloured differently, the pattern being black and the ground yellow, green, or turquoise, specimens of some of these in a mutilated condition exist on some of the piers on the north-east façade and others are found in the Dome of the Chain. The great inscription (partly illustrated in Fig. 34) over the

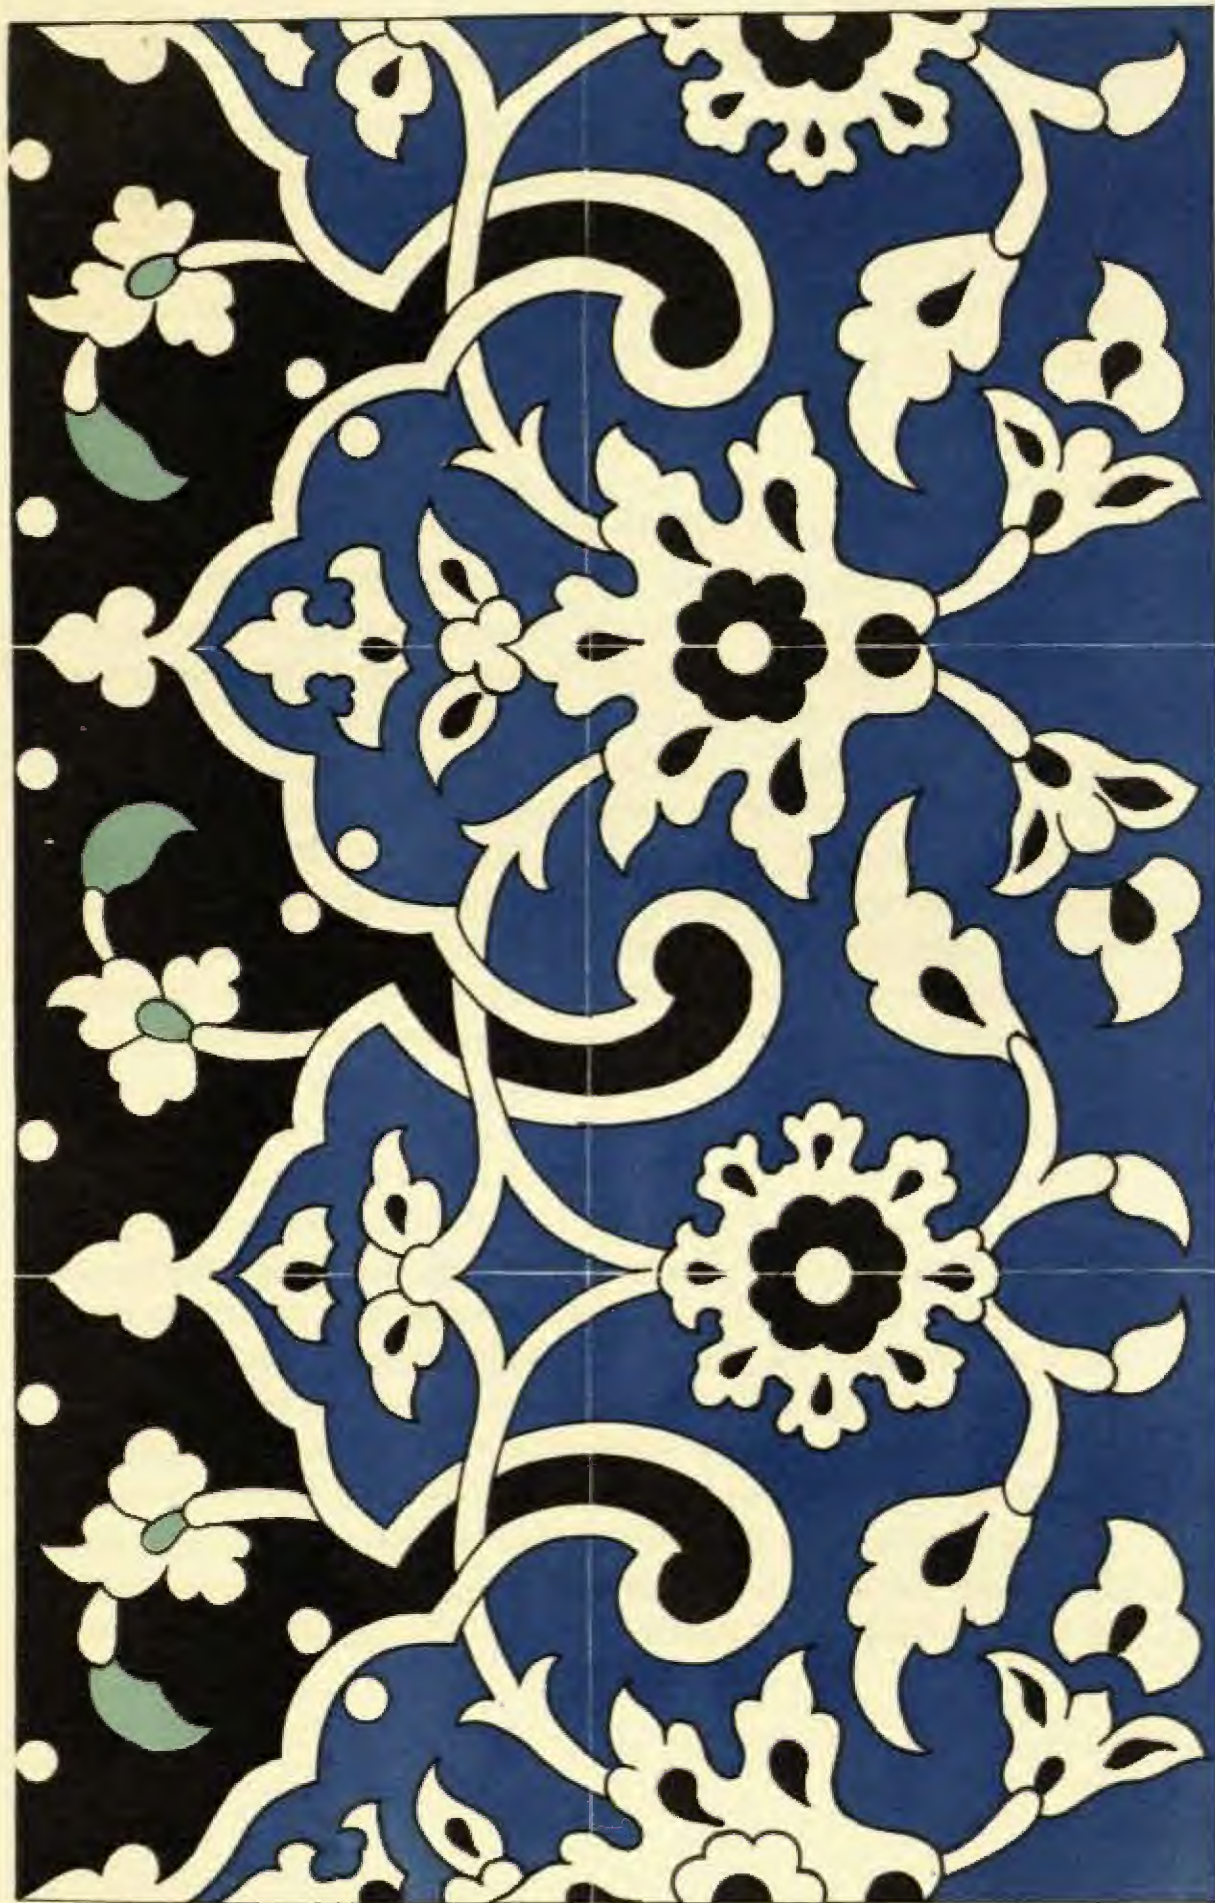
Fig. 23. A design in imitation of battlements ('Sharafat')

Scale 1 : 3

intention to the stone battlements (known as 'Sharafât') that crown the walls of so many Muslim buildings. The reconstruction of this design is shown in Fig. 23. No doubt these tiles were made to crown the top of the octagon. At one time there must have been more than 1,200 of them; now only eight badly mutilated specimens remain. The battlements are outlined in white, their ground is dark blue and the ground of the spaces between them is black; the flowers and stems are white where they are laid on a blue ground, but some turquoise is used for those on a black ground. The other design consists of two interlacing stems, each having large flowers; the stems are white; the flowers are mostly black-and-white, but turquoise is used in some of them; the ground is dark blue. The design is bold and is evidently made to tell at a distance. The flowers are similar to the flowers of the border patterns illustrated in Fig. 16, but are further elaborated. This design is shown between the 'Sharafât' and the inscription in Fig. 41, which represents an attempt to reconstruct the original design of the tile decoration on the parapet wall. The evidence upon which this reconstruction is based will be discussed later. The inscription drawn in this reconstruction no longer exists on the walls of the shrine except for a few fragments found on the drum and there used to divide the panels, formed of early nineteenth-century tiles, that run below the windows on the western side of the drum. About three-eighths of the splendid tiles that formed this inscription have, however, been discovered in various store-rooms existing in the Haram al Sharîf. These tiles have been sorted and arranged in their proper order in the Mugharba Mosque, which is being used as a museum for tiles and other objects found in the Haram. The tiles forming the inscription belong to the same group as those illustrated in Figs. 23, 24, and 41. They

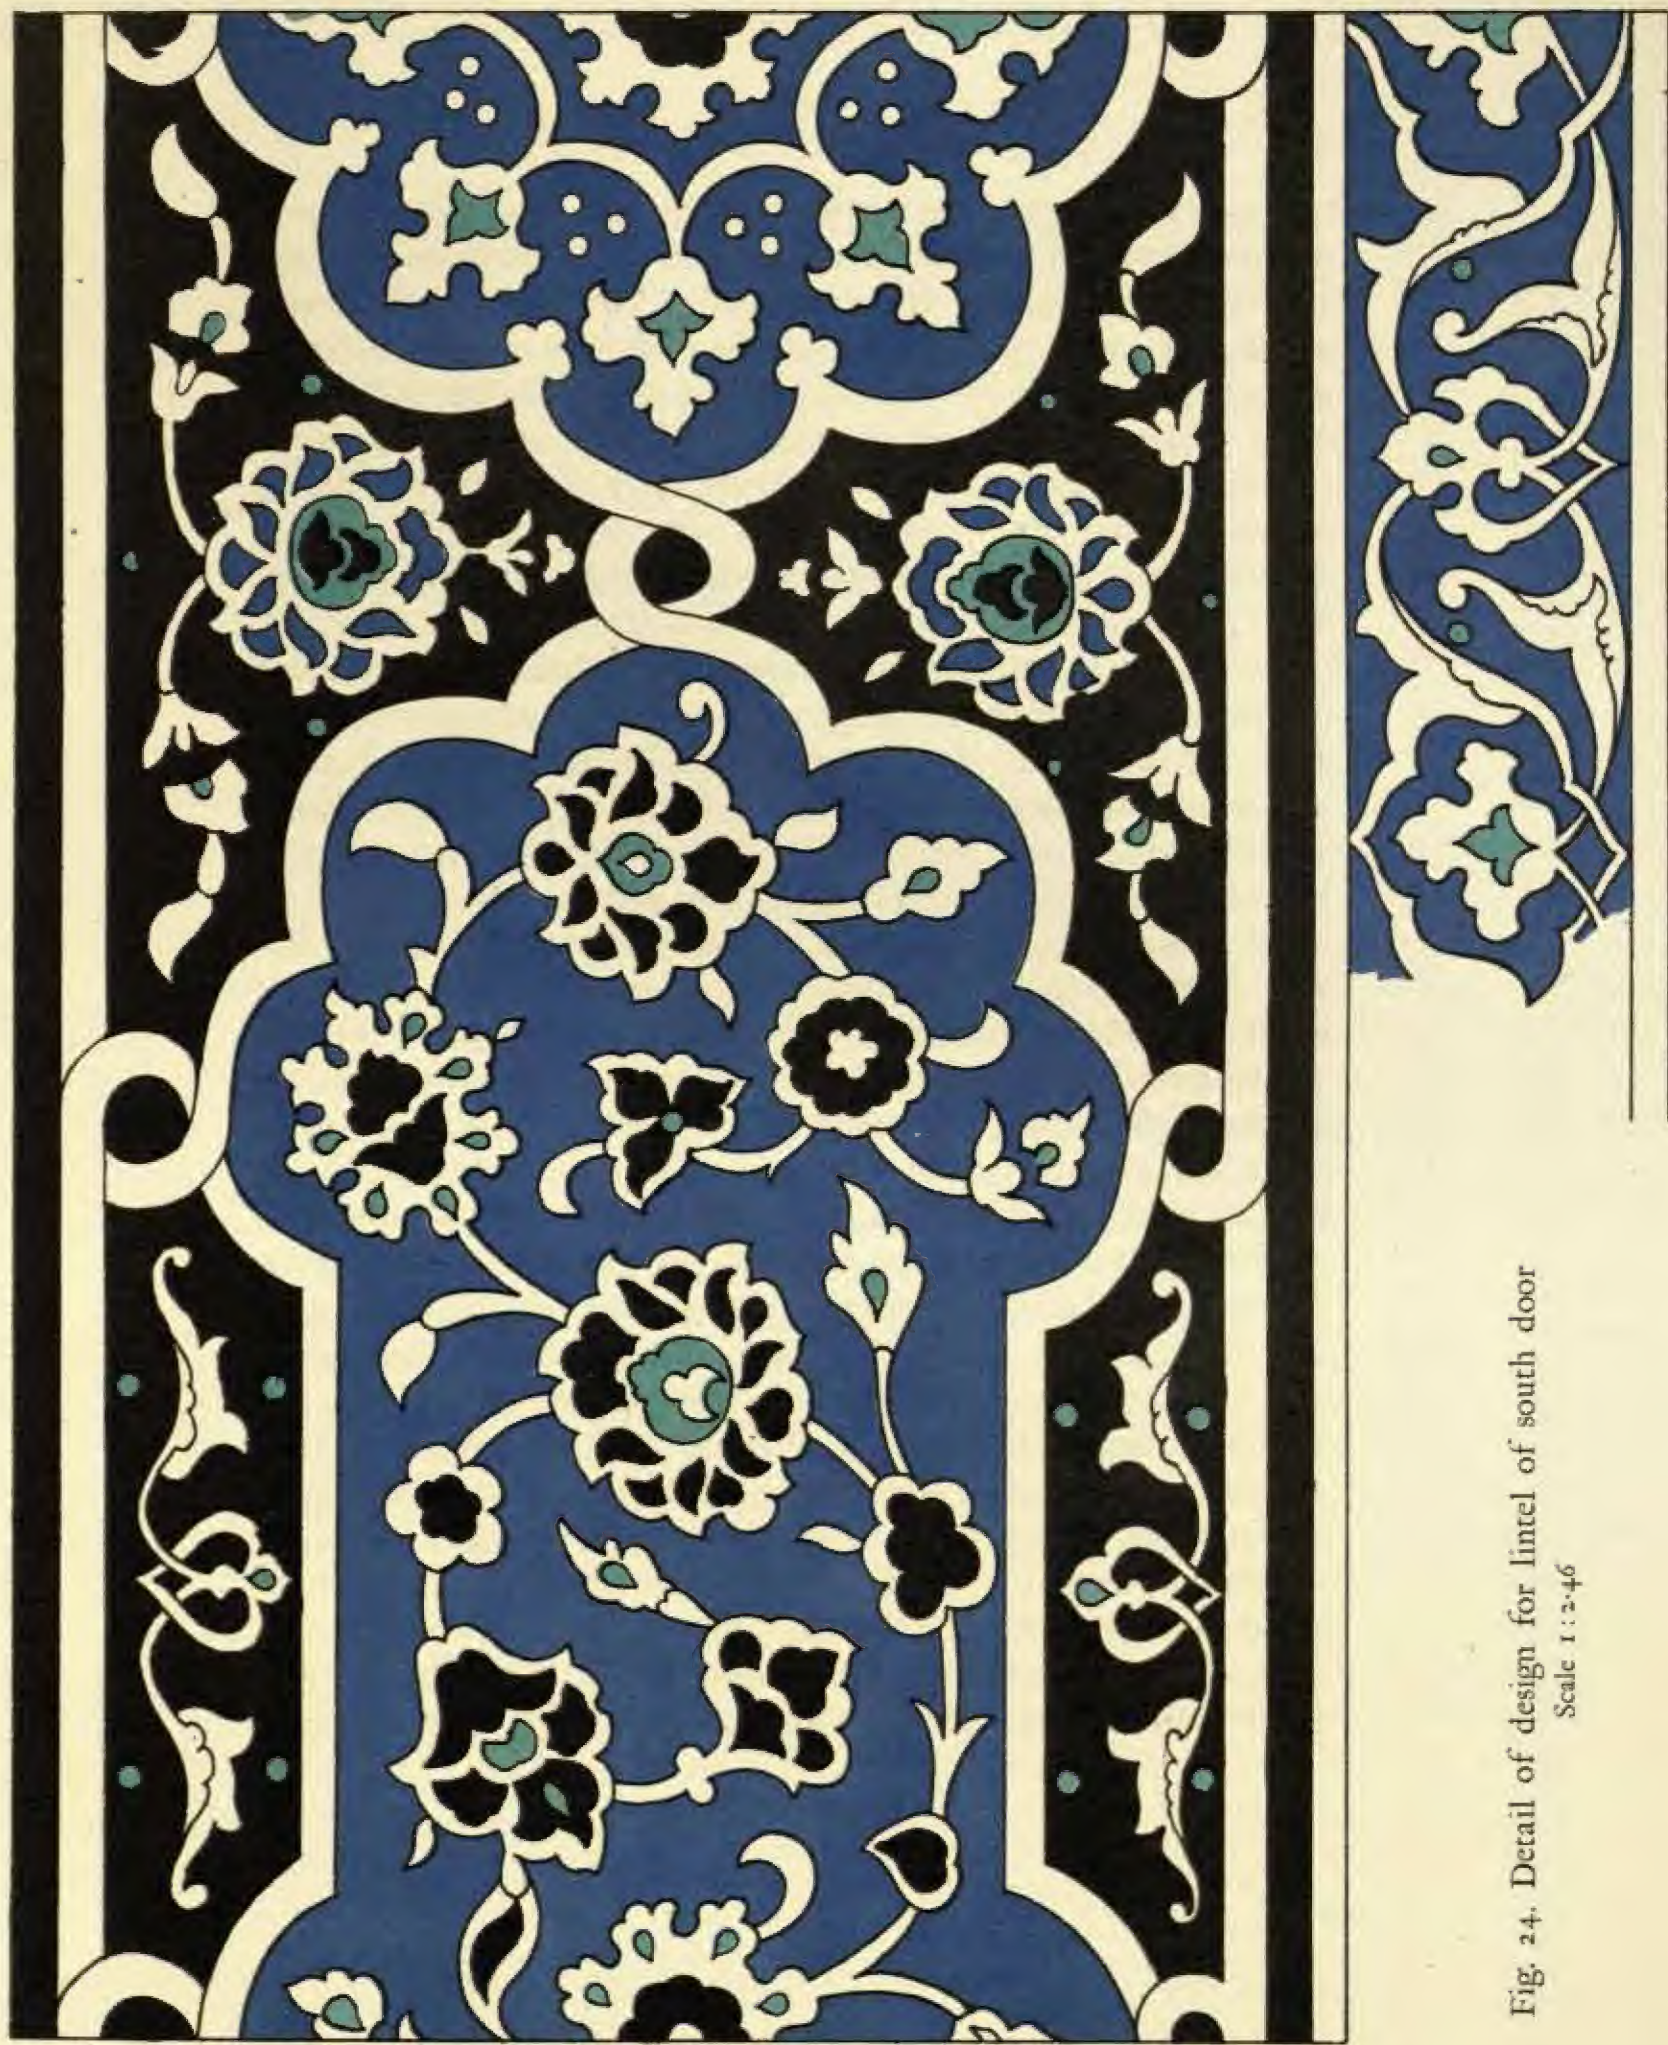
Fig. 24. Detail of design for lintel of south door  
Scale 1 : 2.46

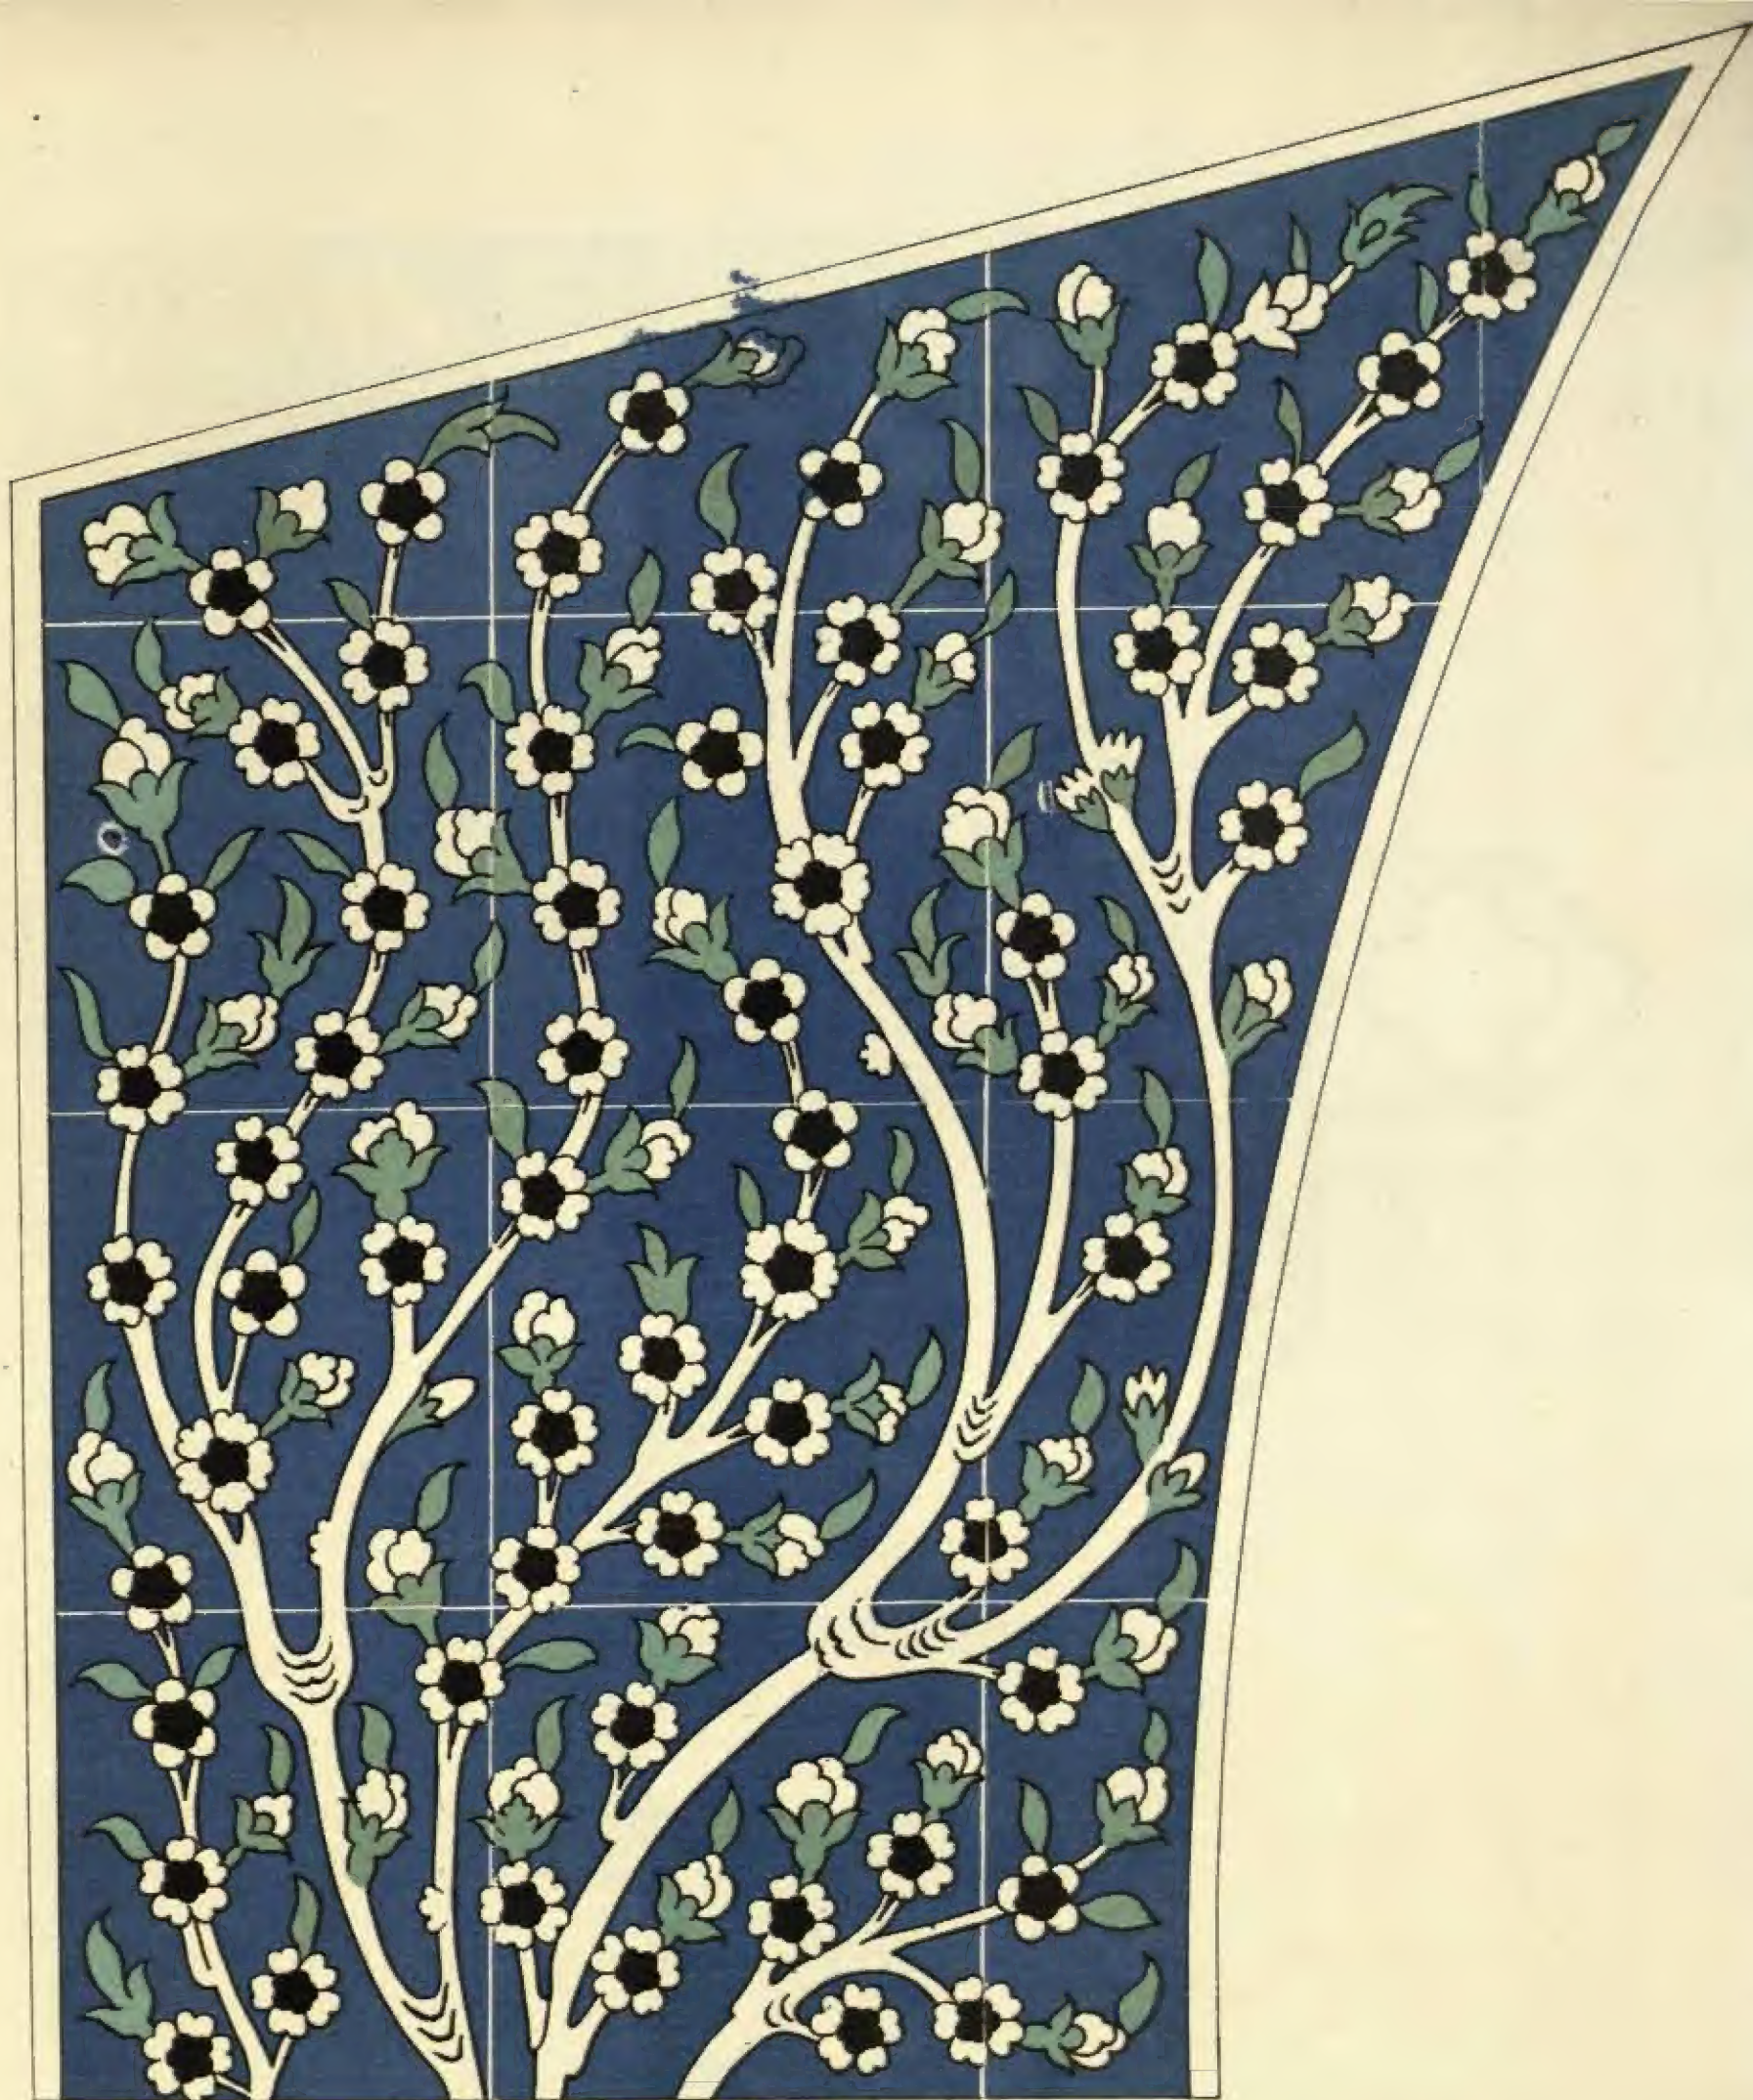
Fig. 28. South Portico arch: decoration of abutments

Scale 1:3. The bottom row of tiles is missing

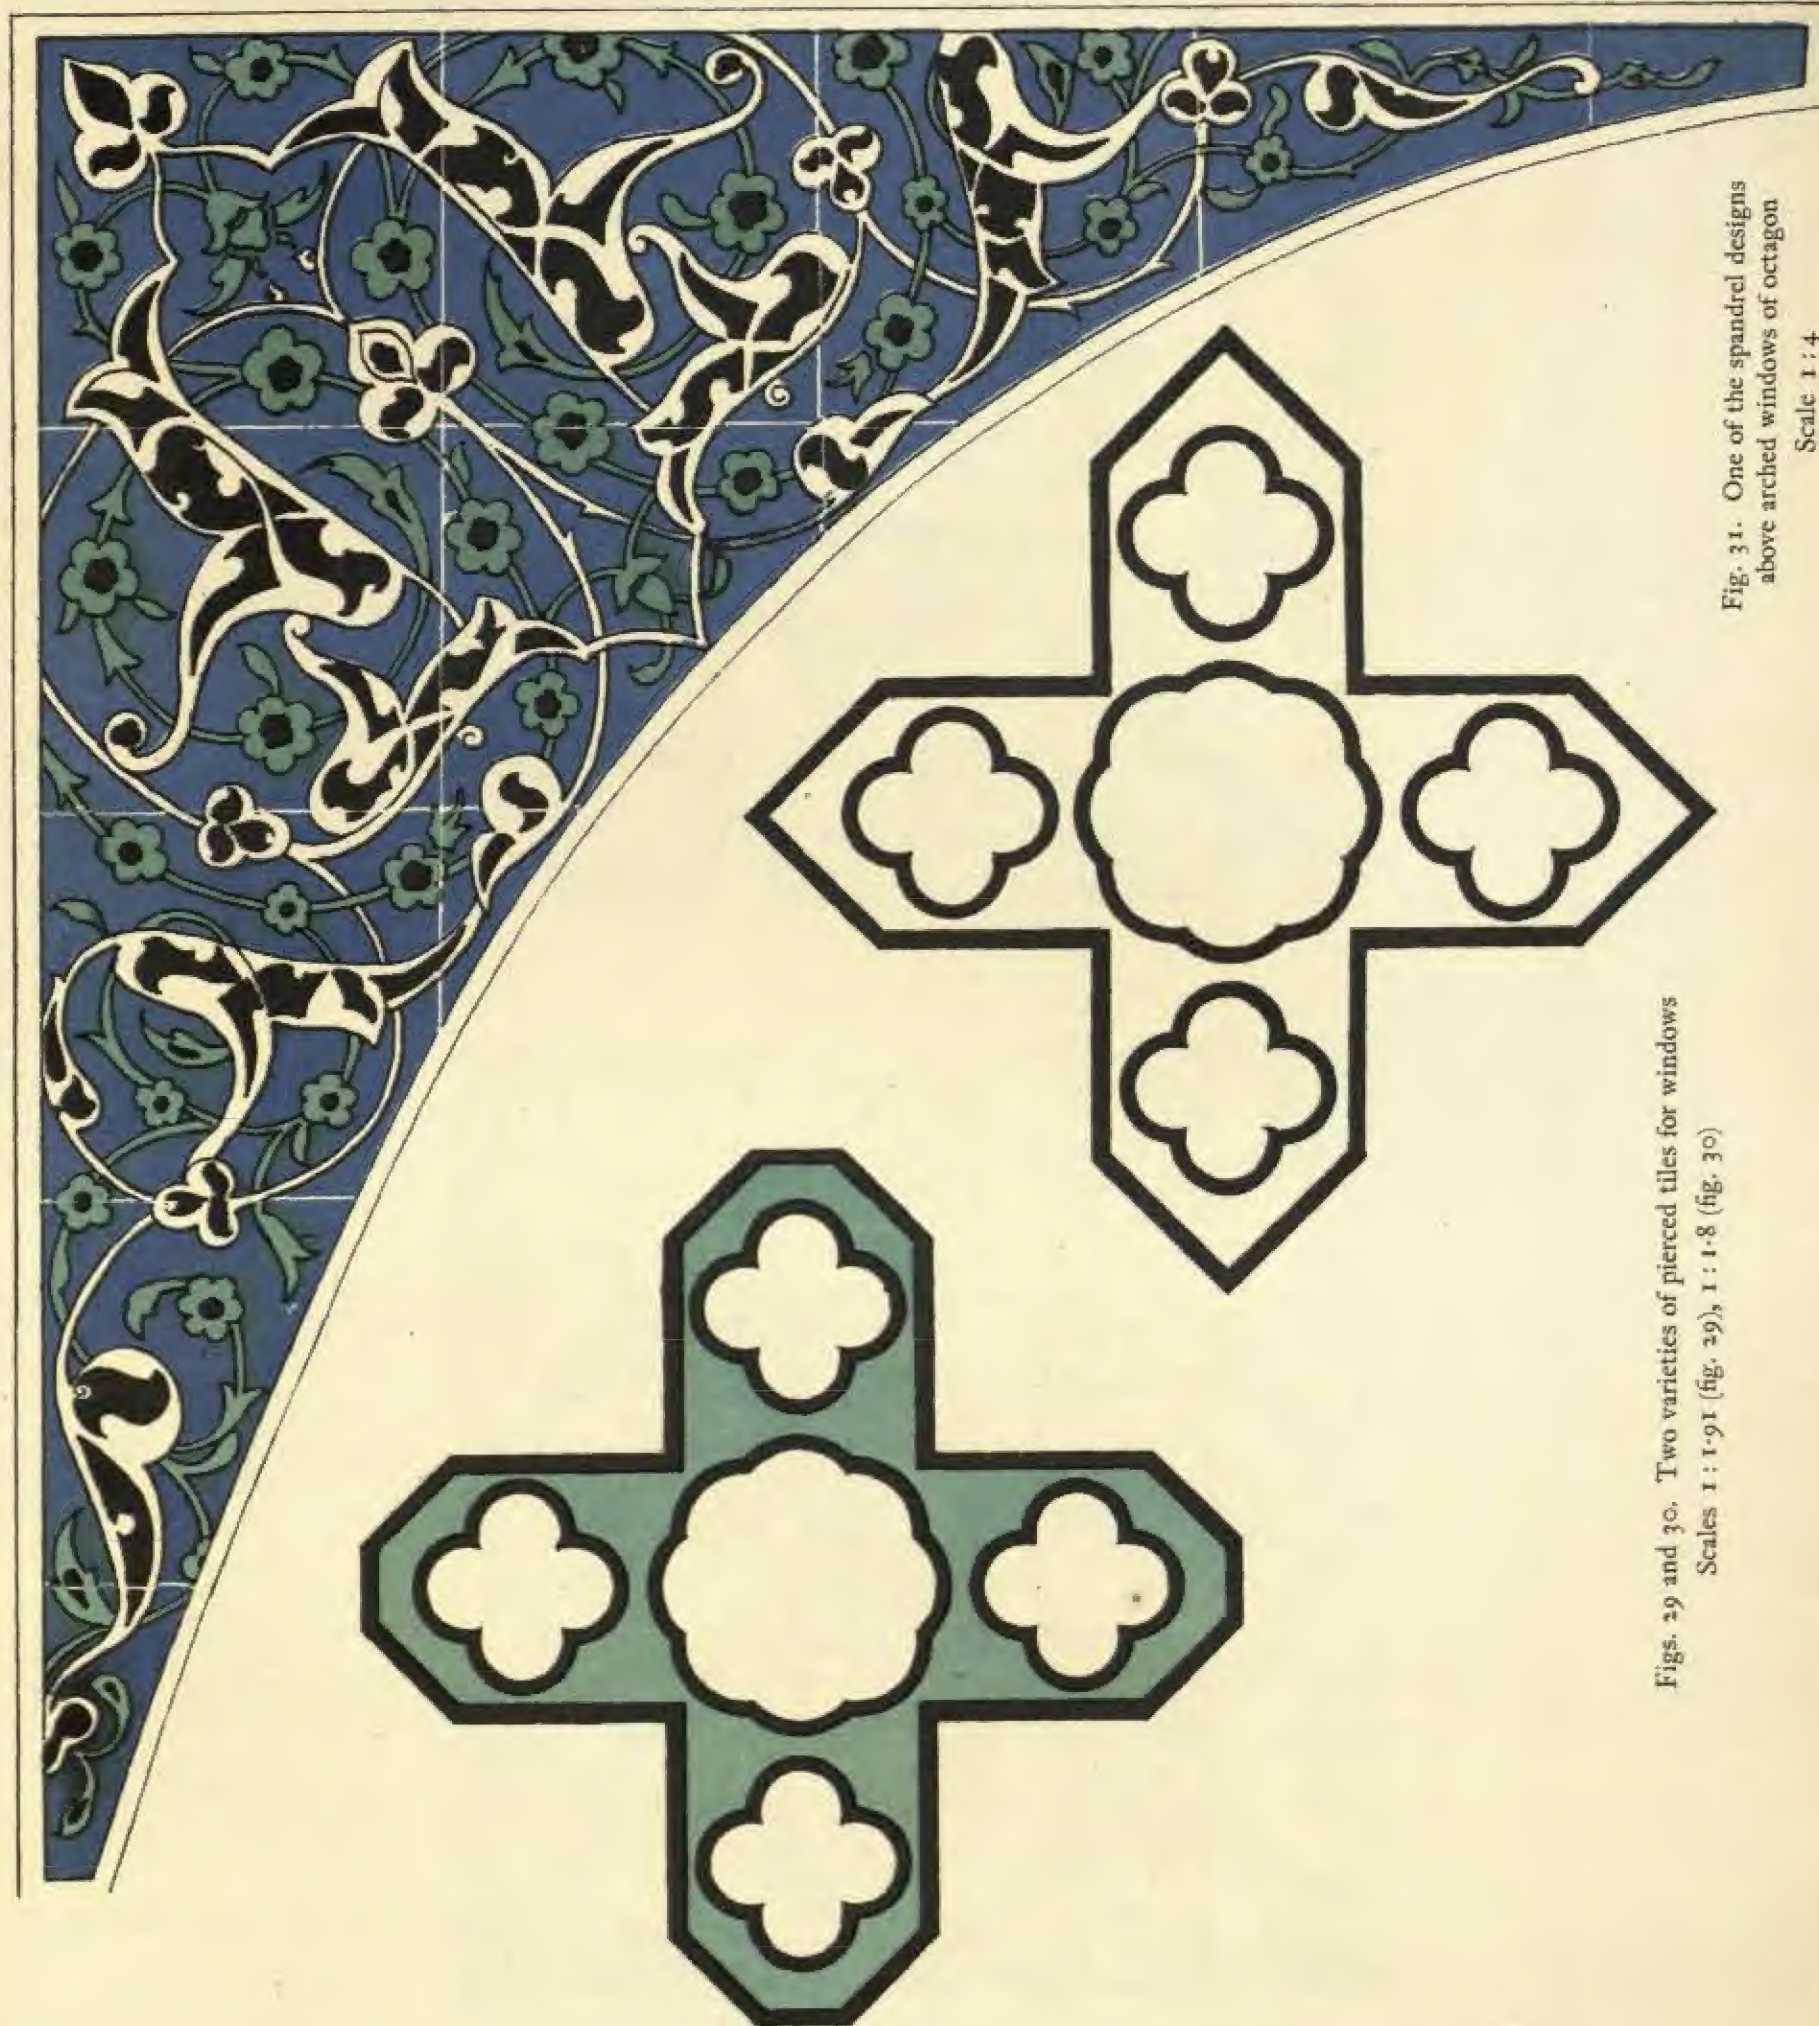
Figs. 29 and 30. Two varieties of pierced tiles for windows  
Scales 1 : 1·91 (fig. 29), 1 : 1·8 (fig. 30)

the architrave are filled with sixteenth-century tiles, as are the spandrels and the portico, the blind bay being filled with fifteenth-century tiles. This drawing is only intended to illustrate in broad lines some of the conclusions reached from the examination that has been made. It would not be hard to justify a more elaborate reconstruction. Inscribed panels might be placed in the architrave above the windows and also in the blind bay and instead of only turquoise-blue quoins to the windows enclosing pierced tiles of black on white, aubergine quoins might be used for some windows, as well as other varieties of pierced tiles (see Figs. 29 and 30).

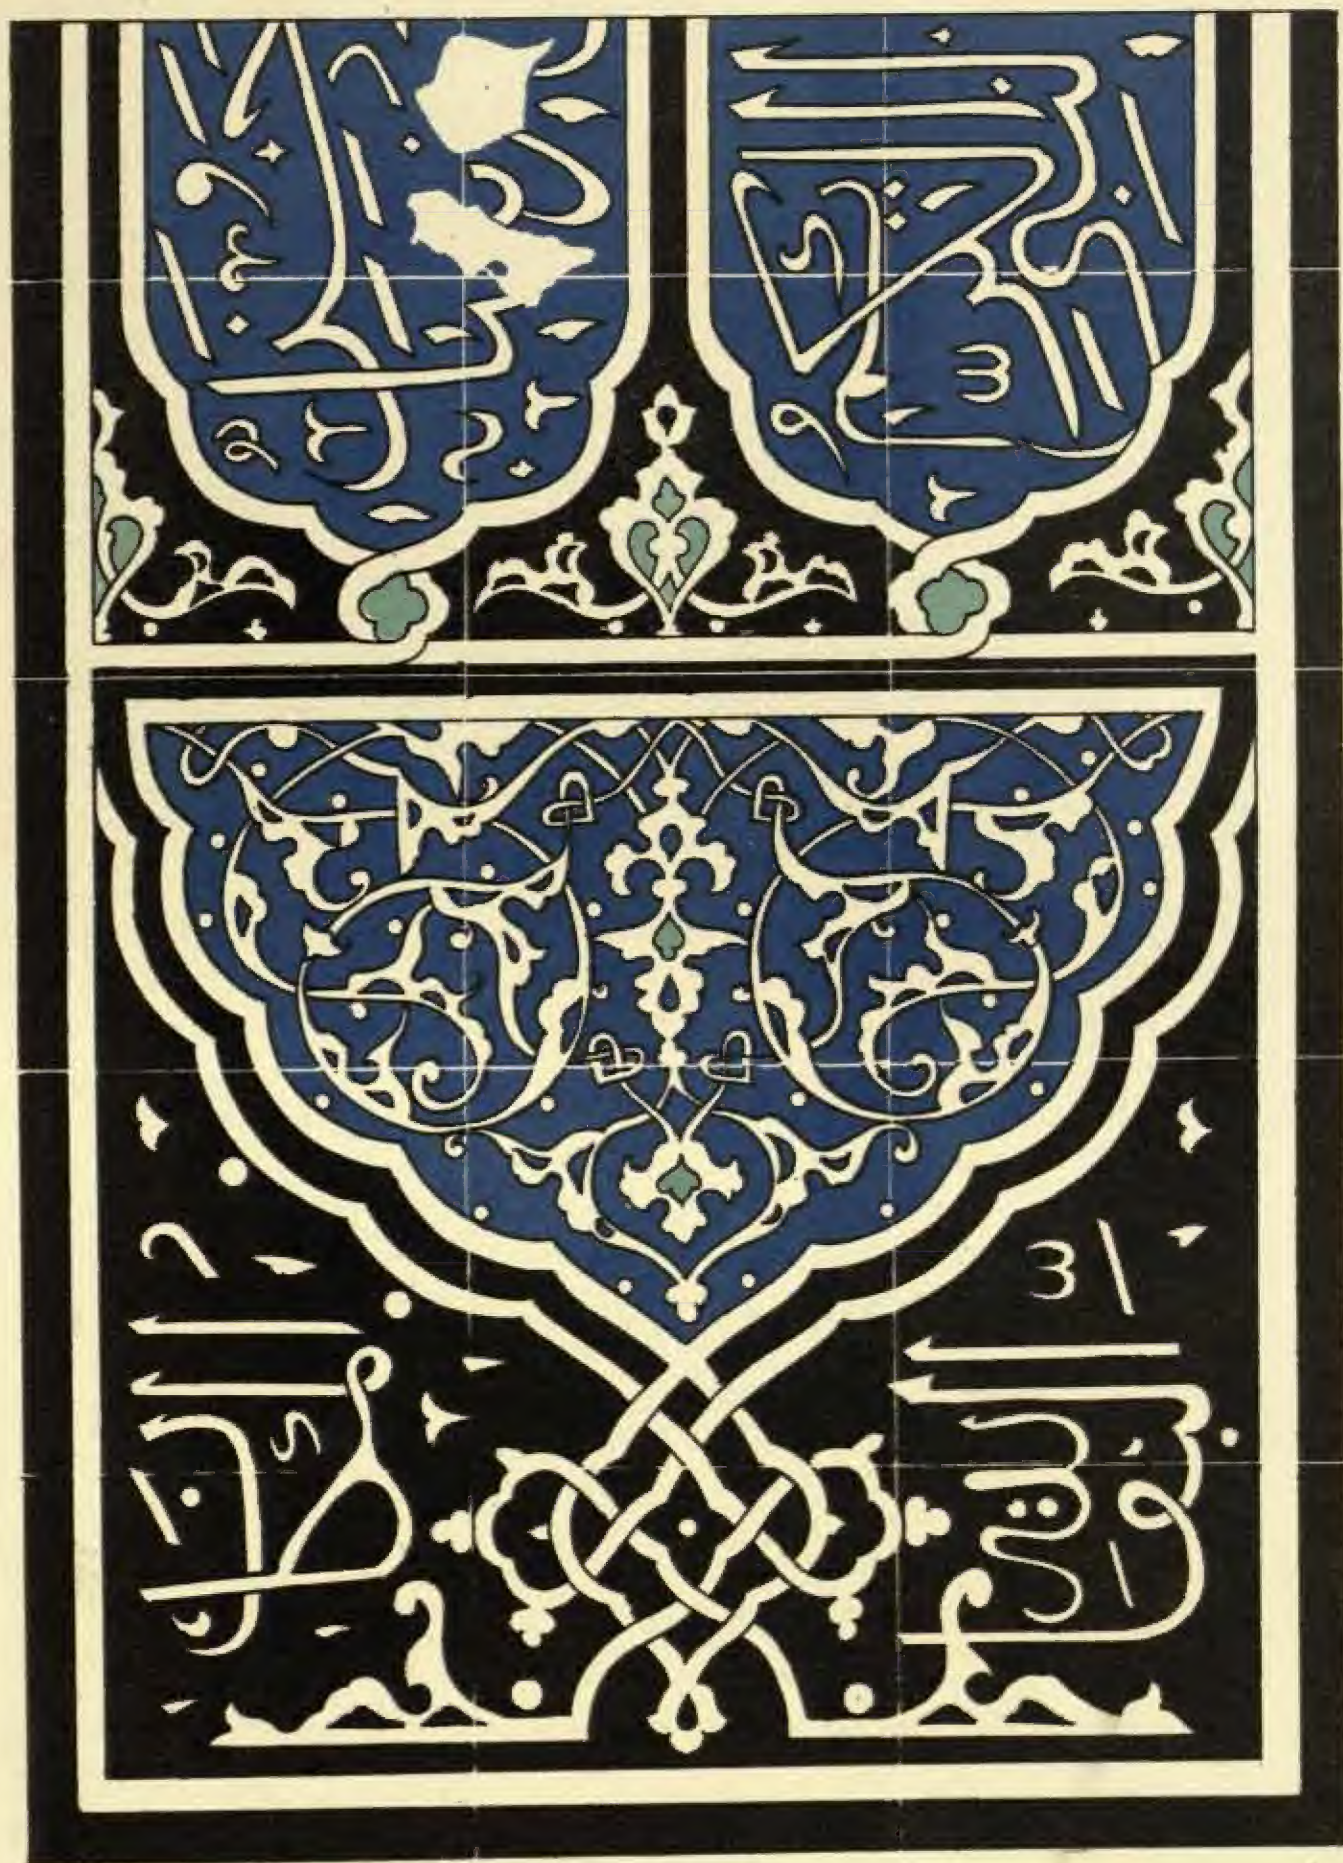
Fig. 34. Terminal decoration of a panel containing 73rd verse, chapter xxxix of the Koran

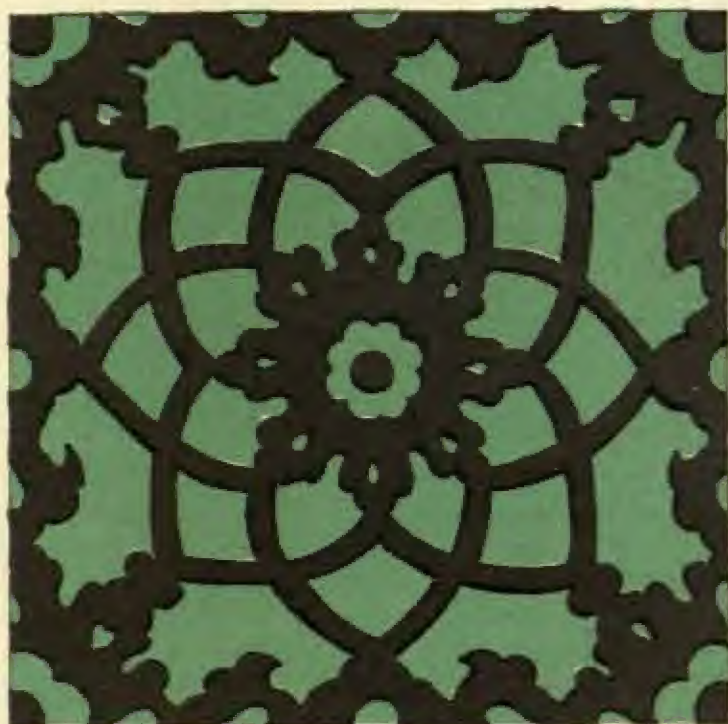
Fig. 35. Specimen of a design found in many varieties of colour  
Scale 1:2

The last category of the tiles grouped in the second period consist of tiles that resemble those of the type just described, but show a falling off both in draughtsmanship and in technique. Forms are expressed with less precision and with less understanding of the original intention, and the application of the colour is no longer so carefully attended to. The fine stippled effect is not found. The colour is laid on roughly, so that the strokes of the brush are visible and the result uneven. Though the floral pattern (Fig. 40) that runs under the cornice on the north façade, and of which specimens are found in the blind bays of the north-east façade, belongs, in its design, rather to the preceding group, its execution shows that the tiles were made at the same period as those of the group now being considered. Many of the cornice tiles also belong to this period, so do a proportion of the tiles forming the window borders and the inscriptions above the east and the south doors on the main walls of the octagon. Another inscription, similar in workmanship, exists above the Mihrâb in the Dome of the Chain. This inscription is dated A.H. 969 (A.D. 1561). To the same period may be attributed a number of tiles of the design shown in Fig. 35. This design is found in many varieties, in green, yellow,
